First Alert – 13/04/2017

PLTR LNE & EM Peterborough- Cricklewood TRM

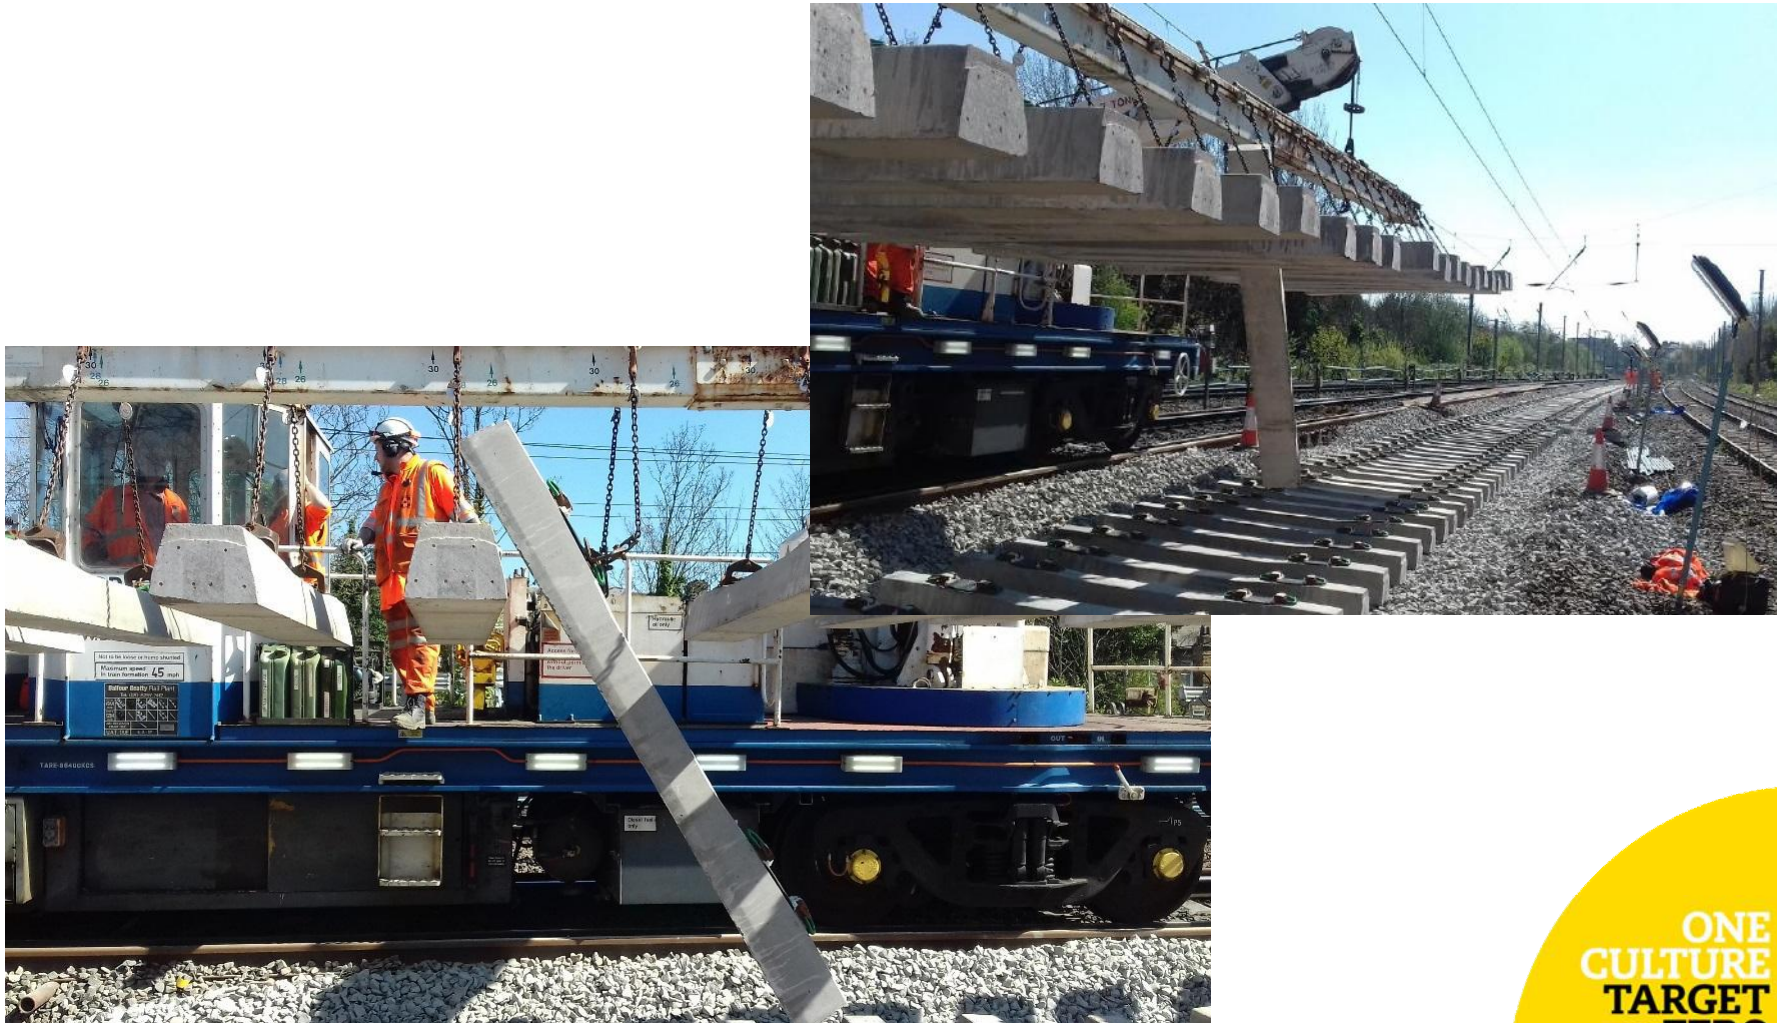
During track renewal work a Track Renewal Machine (TRM) was moving sleepers into position when one end of a sleeper fell to track level.

Although the lift was fully planned, the sleeper had not been fully secured in place and the movement of the lift dislodged one end.

There were no injuries or damage as a result of the incident.

- Ensure all loads are 100% secure and all fixings seated correctly before completing planned movements.
- Ensure exclusion zones are in place and complied with.
