Point 2127B run through at Down Temple Mills

LESSONS LEARNT

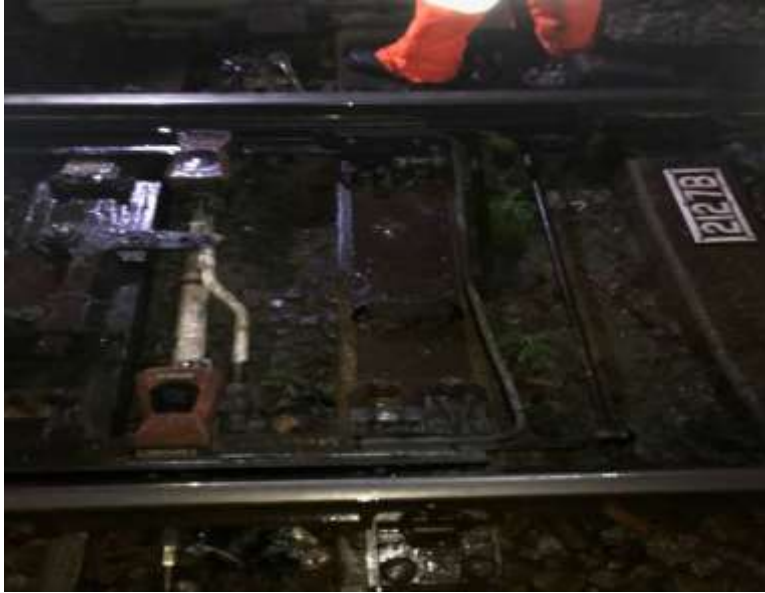
- Whilst operating between the Down Temple Mills and Cement works sidings, a Doosan 270 with a trailer run through 2127B trailing points. The RRV was meant to take scrap material from the Down Temple Mills (towards country) to load onto train stabled on the Up Temple Mills. However the points were set in 'Reverse' instead of 'Normal', resulting in RRV travelling over a wrongly set point.

- The Crane Controller did not check to ensure the route was set correctly before allowing the machine to pass.
- The Machine Operator did not challenge the Controller to verify that the route was set for the planned route.
- Poor enforcement of the points control process resulting in the point movement and setting not being communicated properly.

- Crane Controller must always take time to check the point and ensure it is set correctly for the intended route every time before crossing it.
- your work environment before and during your work, such as Time out, Take 5.
- Even if the task is repetitive, make sure it is getting done safely every time.

- Effective deployment of Til Dawn lamps.

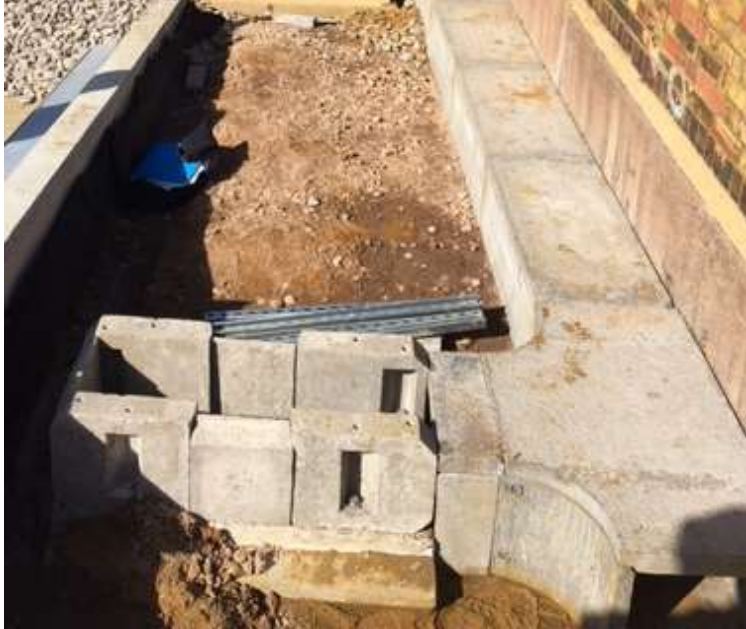
- Whilst installing troughing lids a contractor trapped his hands under the lid. The accident resulted in a minor crush injury to his left middle finger. The IP received first aid and was fit to continue with his duties after a short rest.

- IP did not have adequate experience of handling troughing lids.
- Team lift was poorly coordinated by IP and his colleague.

- Always evaluate your intended activity before starting your work?
- During manual handling team lifts, ensure you understand the agreed coordination and control of the lift.
- Ensure you take time to check your work environment before and during any activity, remember to take 'Time out, Take 5'.

- Always use suitable handling aids to eliminate risk to hands, example below <https://www.jafcotools.com/product/insulated-trough-cover-lifterlid-tilter/> :

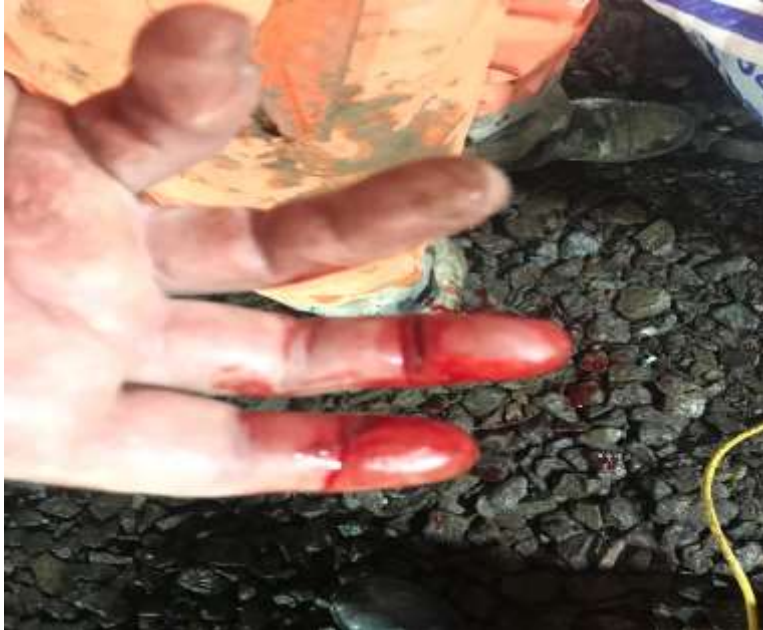
- The immediate cause was due to the fact that the operative had swapped from the Cut 5 gloves he had been wearing during the coring works itself to a pair of waterproof gloves whilst he was measuring the depth of the core.
- By proceeding to wipe the tape measure clean the gloves were cut through.
- The waterproof gloves the operatives was wearing wasn't cut 5 gloves hence being able to cut through easily.

- When undertaking civils activities, the planning should consider the volume of water required to carry out the task
- The appropriate PPE Should be specified in the task brief (Waterproof Cut5 Gloves)
- Review of PIC/Coss/Supervisor of applicability of PPE for each activity
- Ensuring full PPE is worn at all times.

- Briefed out regarding the availability of Waterproof Cut 5 gloves

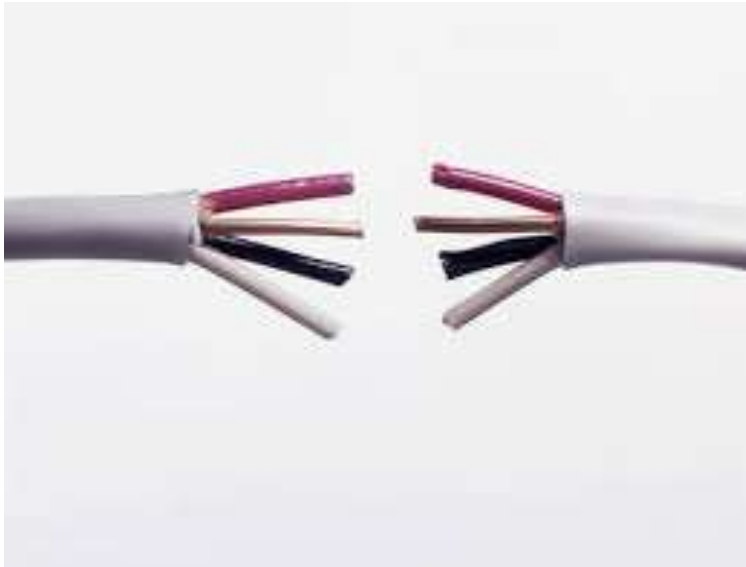
- The operative was disc-cutting through tarmac on Platform 9 at Watford Junction when the supervisor on site noticed that the display information screens (CIS) had gone out.
- The operative had cut straight through a buried cable within the tarmac.

- The cable routings within the platform are non-compliant and do not follow a straight path
- Cat scanner did not pick up areas where the cable was buried under tarmac
- Review methodology for cutting platform near existing assets on the platform (lighting poles / CIS Systems)
- Having E&P cover on-site whenever we are cutting in the vicinity of an E&P asset

- Minimise the cut lines for the platform drainage near assets
- Revise methodology to hand held breakers to minimise depth of breakout (and associated clearance of arisings) for a more measured and visible breakout procedure

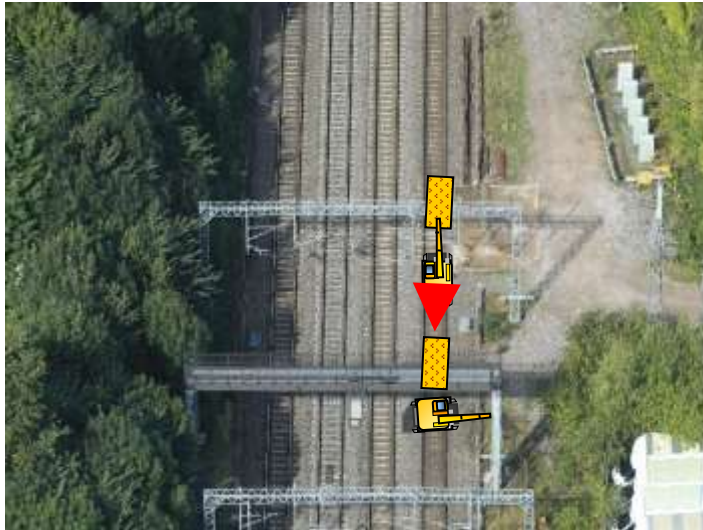
- A low speed collision happened between two RRV at the BRSA RRAP.
- Both RRV's where at the RRAP trying to offload at the same time.
- While offloading they came into contact with each other from one of the machines setting back slightly.

- To de-conflict two working machines when at the RRAP
- Crane controllers to maintain exclusion zones between machines
- Crane controllers to walk behind the machine at safe distance and out of harms way when reversing the machine, regardless of how small a move.

- Exclusion zone of 10m to be maintained at all times.
- Only one machine to be on the RRAP off loading at all times

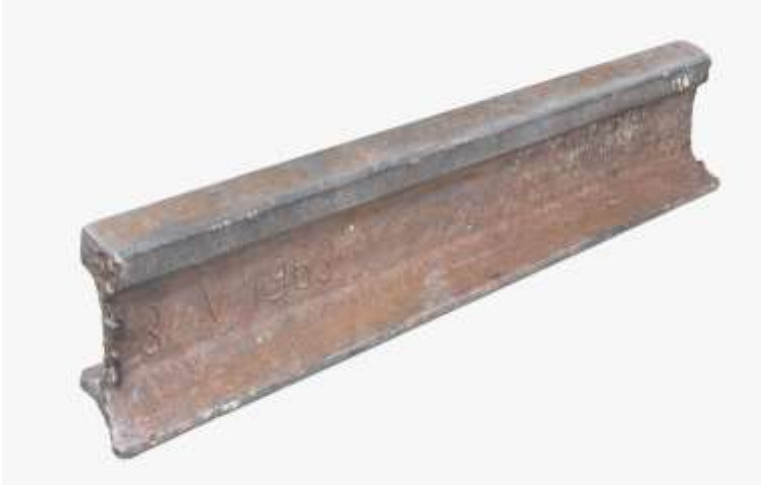
- An operative incurred bruising and swelling to his left hand when lifting a piece of off-cut rail.
- The operative tried to lift the 40kg piece of rail by himself onto a RRV trailer when it slipped which resulted to having it dropping on his hand.

- Where possible, offcuts of rail should be cleared immediately with the use a RRV if available
- During Site Clearance PIC to identify scrap that should not be manually lifted
- Individuals to reconsider what is a comfortable load to individually handle

- Machine to carry out scrap clearance activities
