# LESSONS LEARNT

## Point 2003B run through at Euston

SCO Ref	43046
Type of Incident	Points Run Through
Project	Euston Enabling Works
Injury/Damage	Damage of 2003B points that included adjustable stretcher bar, lock rod, drive rod, long detector rod and short detector rod.
Date	08 <sup>th</sup> July 2019
Time	0230
Location	Euston Station

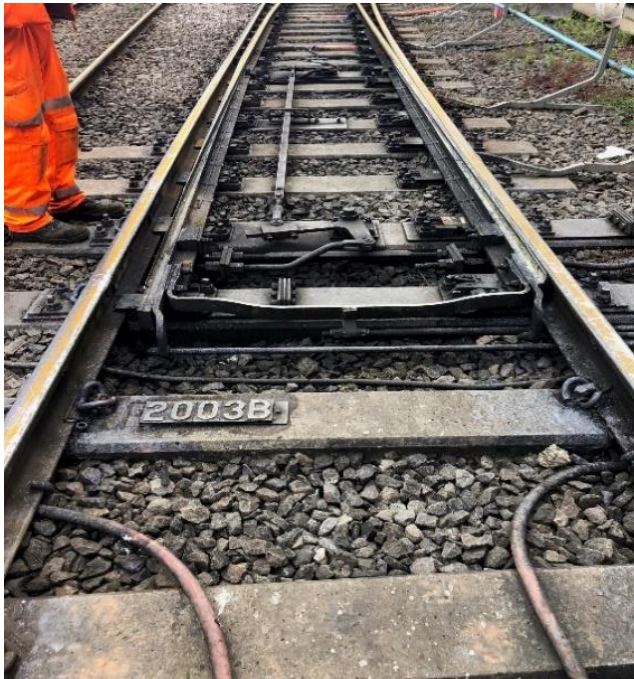
On 08<sup>th</sup> July 2019, 2003 Bravo Points going into platform 16 at Euston were run through by a Mobile Elevated Working Platform (MEWP)

- A MEWP made an unauthorised movement across 2003B points as the MC made a decision to follow his colleague across the points without stopping and having the Points Operator set the route for him
- The MC was walking in front of his MEWP but had failed to check the points and knew that the points had been set against the direction he was traveling in.
- The ES was notified of the potential points damage at 0410 and an on call S & T fault team was present on site but were not notified of any damage until 4 hours later at the end of the shift.
- The Till Dawn Process was implemented but was not followed on this occasion.

- *MC to receive confirmation from PO that the required route has been set before proceeding.*
- *MC to ensure that they walk in front of OTP and visual checks of S & C are conducted before proceeding.*
- *ES to ensure that PO has sufficient Till Dawn Lamps available and agrees pre planned locations for installation.*
- *Persons that are deployed in Safety Critical roles are to collate full and accurate records of documentation used in their works*

- *Engineering Supervisor to prioritise all reports of potential infrastructure damage in real time and report to fault control for action.*
- *The MC was walking in front of his MEWP but had failed to recognise that the points had been damaged.*
- *Always follow the Till Dawn and Points protocol process*
