Train makes contact with site material

Ref: NRB19-08

Date of issue: 29/06/2019

Location: Blisworth, West Coast Mainline South, LEC1

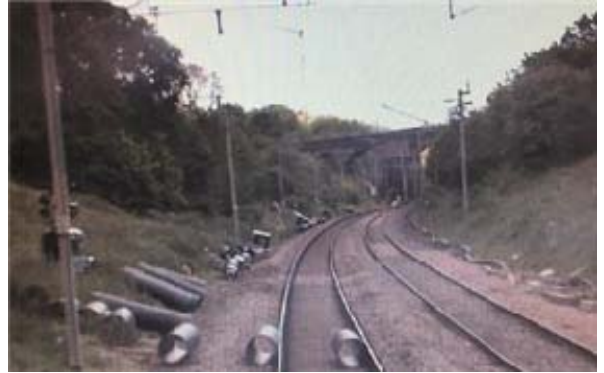
On 28/05/2019 at 17:55, the driver of 1A52 reported that objects had been placed on the Up Main line. The objects were subsequently identified as two drainage pipes (each 500mm diameter, 2m long and weighing 68kg).

The train struck the pipes, sustaining minor damage and causing damage to track fixings, axle counters and an overhead line structure. As they were pushed along the line the pipes filled with ballast, increasing their mass.

The pipes had been left on the lineside by contractors undertaking drainage work in the area during available possessions. Neither the pipes struck by the train nor others stored at the site had been secured to deter interference by vandals.

At this stage it is not confirmed how the pipes came to be in the path of the train. A Level 2 investigation is underway and will explore whether they were moved by persons unknown or by the physical effects of passing trains.

- Have your sites ensured that their security arrangements are adequate to prevent unauthorised access to the infrastructure?
- Are lineside materials secured as a minimum in accordance with NR/L3/MTC/RCS0216/GA25 (Line Side Materials and Equipment) and based on a risk assessment?
- Have all existing materials left line side been identified during the AMP/dilapidation survey, and have arrangements for removal been made?
- All Principal Contractors must risk assess the storage of lineside materials.
