Safety Bulletin

Serious Safety Incident

Issued to: All South East Route

South East Route

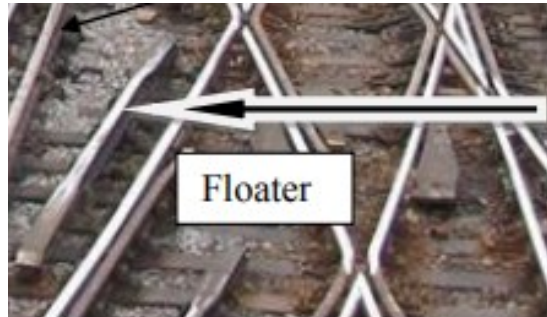
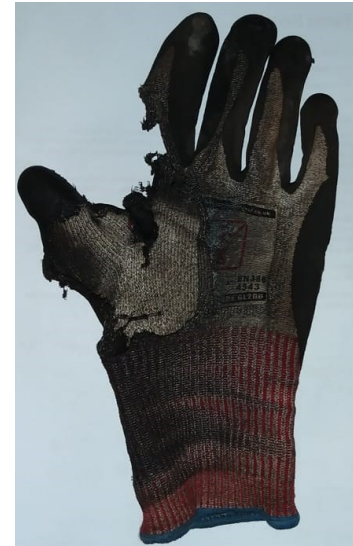
A serious safety incident occurred last night when a colleague setting up site lighting came in to contact with the live conductor rail. The live rail was a floater believed to have been isolated (example of a floater above)*.

Floaters are short lengths of conductor rail that can abut or infringe an isolation and can remain live because they are fed from an adjacent live conductor rail in a different electrical section.

Never assume equipment is isolated
– always test before touch.

- Always assume that the third rail is live and test before touch
- Are you aware of live floaters in your worksites?
- Always wear the correct PPE for the task
- Are you indicating live floaters on site using devices such as self-testing conductor rail indicator devices?
