# Shared Learning

## Fall from height - staff injury

Ref: NRL19-11

Location: UB304/004 Todholes, Scotland

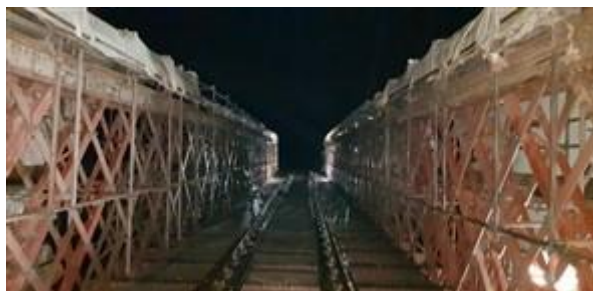
Whilst walking at night along a mesh-grid walkway on the bridge at track level, the Injured Person (IP) fell forwards and through a void. The IP fell approximately 1.5 metres down onto the scaffold deck below and sustained bruising to the side of his body.

Walkway panels had been removed to allow workers to pass materials up from the scaffold deck below. However, the IP was unaware of this. The IP attended hospital and had to take time off work to recover from his injuries.

- A change in work activity occurred.
- The change was neither adequately planned nor risk assessed.
- The Task Briefing Sheet did not reflect the works or arrangements required.
- Suitable controls to address the hazard were not implemented or discussed before or after removing the walkway panels.
- Lighting at the site of works was inadequate.

- Works **MUST** be planned, and risk assessed to avoid late change in the first instance.
- Works **MUST** be re-assessed if late change is required to manage risk effectively.
- Who is responsible for controlling activity on site and ensuring effective communication of hazards and related risks?
- How do you ensure adequate resources are provided on site, particularly in remote locations?
