HEALTH AND SAFETY ALERT

TITLE OF ALERT	HEi089 Accoustic Fencing		
TARGET AUDIENCE	Everyone engaged in site activities	REF NO.	19-ConR-A008
AUTHORISED BY	Paul Harte	DATE ISSUED	29/05/2019

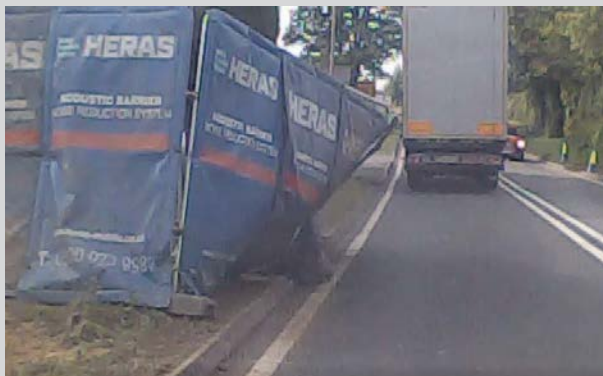
To undertake work overnight and to ensure that noise levels were adequately controlled, Acoustic Fencing was used. When a HGV/LGV passed the fencing (during the daytime), it failed and fell from the verge area into the oncoming traffic striking a car.

- The fencing had been left in situ for several days
- The fencing was positioned less than 1.2m from the edge of the carriageway (0.8m)
- One of the acoustic panels became detached from the mesh fencing allowing for high winds to enter inside causing the end panel to be pushed from the footing and from the couplers causing it to fall to the ground
- The fencing was battered by high winds (causing excessive wind loading) that was generated by vehicles passing causing the fencing to gradually fail

- The fencing was only a temporary solution to reduce noise levels and should have been removed once the road closure had been lifted, but preferably after noisy operations have been completed and replaced with Chapter 8 orange barrier
- Where fencing and acoustic barriers exposed to environmental factors such as wind loading, a suitable temporary design should have been developed

- Ensure that regular checks of the site are completed especially where signage, fencing, etc is left in situ
- Fencing with acoustic barrier to be removed at the end of the working shift or when road closure is lifted/removed, **but preferably ASAP after noisy operations have been completed**

- Where the fencing can't be removed, the acoustic panels should be removed from the mesh fencing to remove the risk of wind loading unless a temporary works design is in place and the fencing has been erected to that design
- Regular inspections of fencing (especially when acoustic barrier is attached) should take place ensuring that it is safe and that it won't cause a danger to the public
- Regular pre-start briefings and toolbox talks to be completed
